**REHABILITATION OF FRANCIS SCOTT KEY BRIDGE**  
**FROM ROSSLYN, ARLINGTON, VIRGINIA TO GEORGETOWN WASHINGTON, DC**  
**DC Contract No.: DCKA-2014-C-0074**

**CONSTRUCTION MANAGER'S**  
**WEEKLY PROGRESS REPORT**  
**From 10/01/2017 to 10/07/2017**

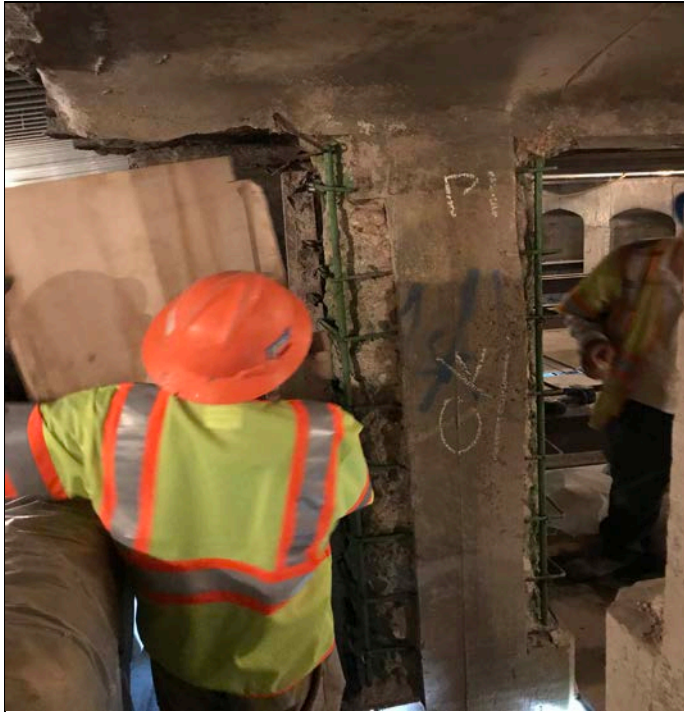
Installing formwork at Span C deck pedestal A34

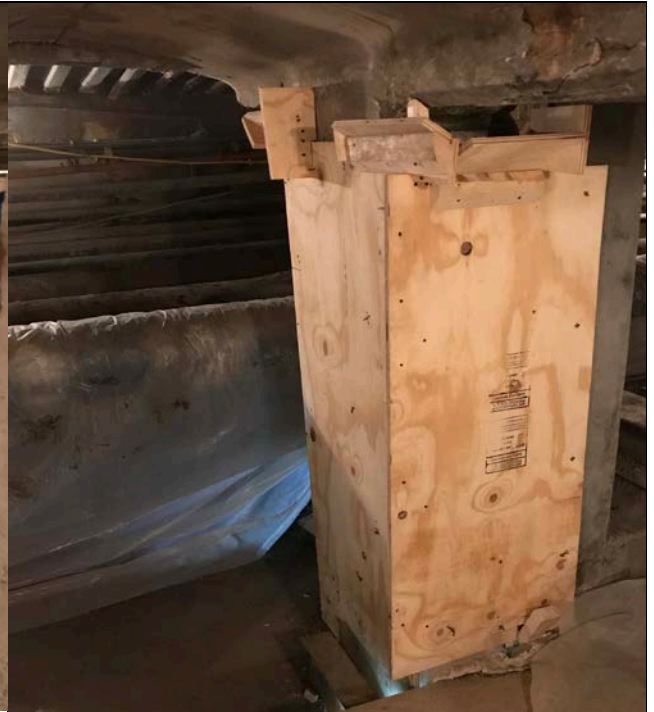
Finished formwork at Span C deck pedestal A34

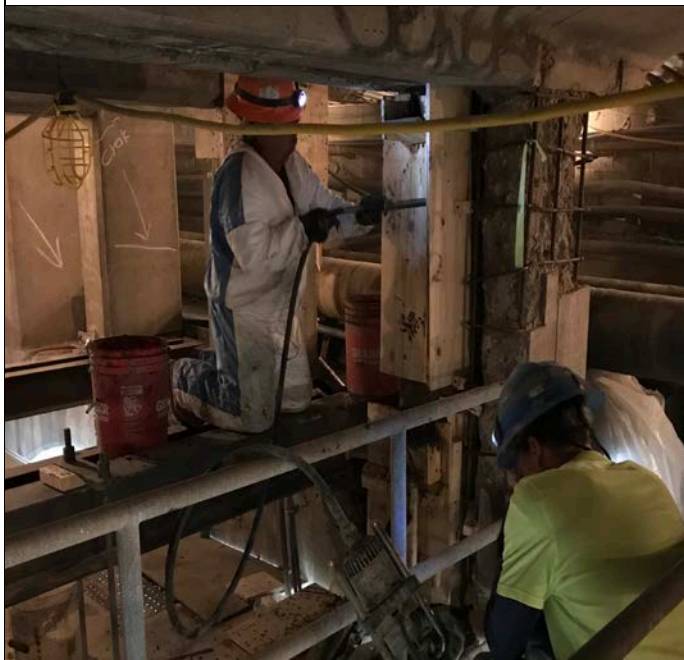
Pouring and vibrating concrete at Span C deck pedestal A25

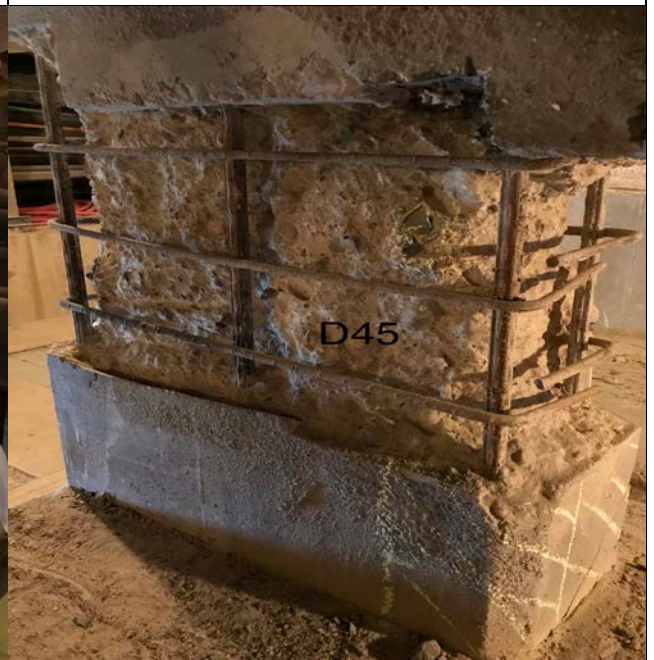
Inspection of Span D deck pedestal D45 concrete demo

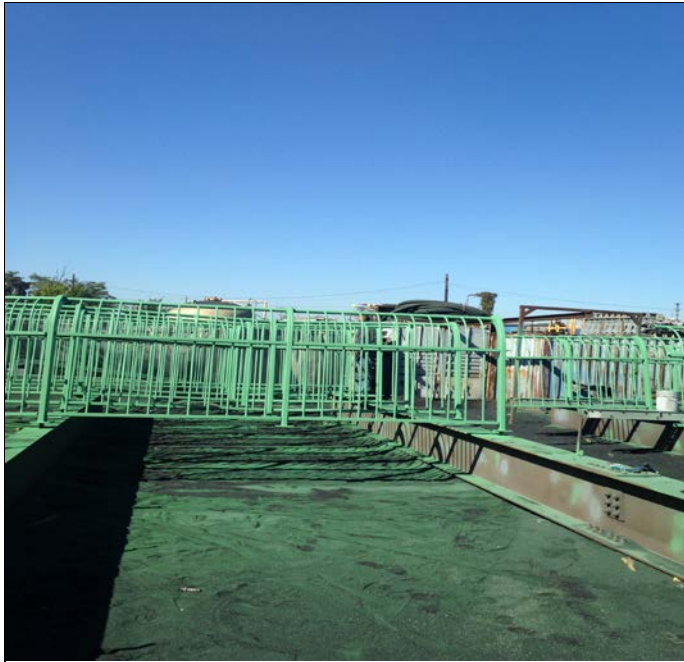
Applying finish coat for pedestrian railing

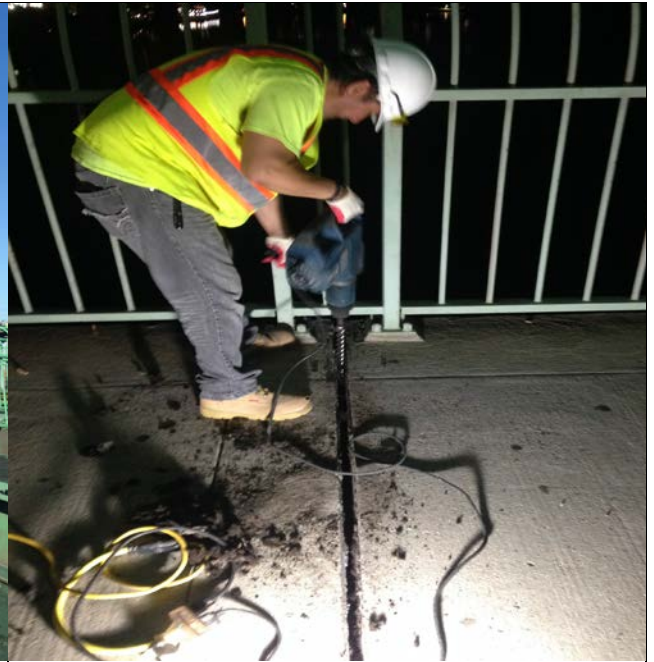
Cleaning and clearing of the dust and debris at non-armored bridge deck expansion joint seals.

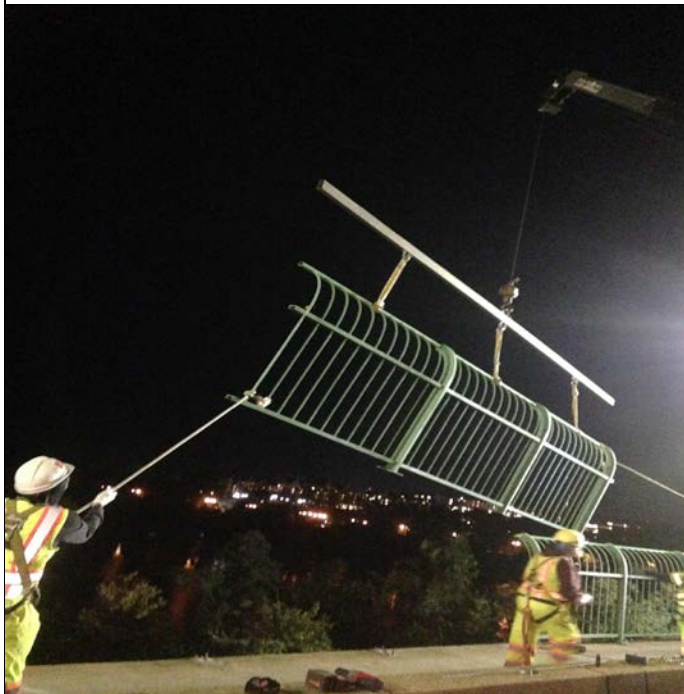
Installing pedestrian railing

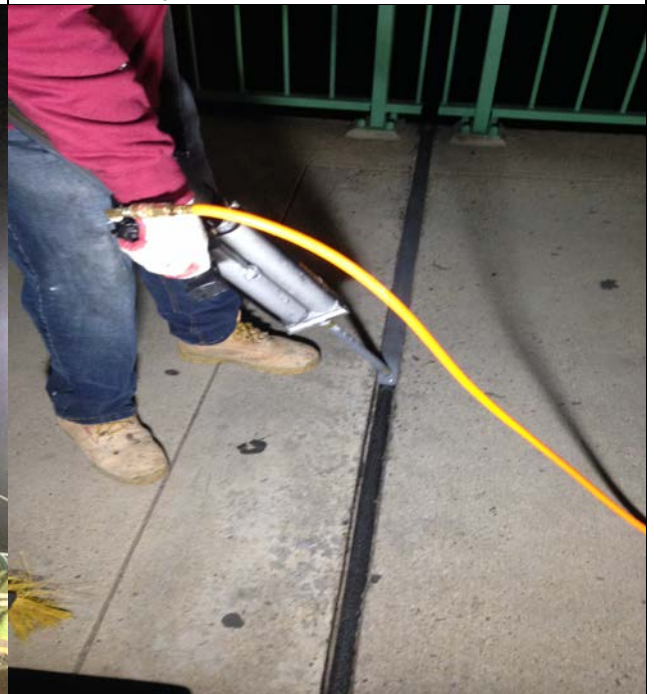
Replacing non-armored bridge deck expansion joint seals

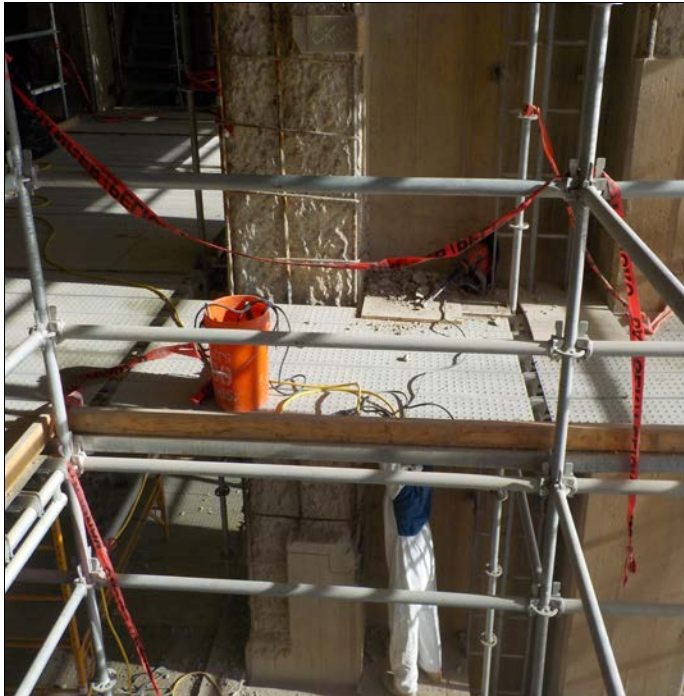
Concrete saw-cutting and chipping at Span E

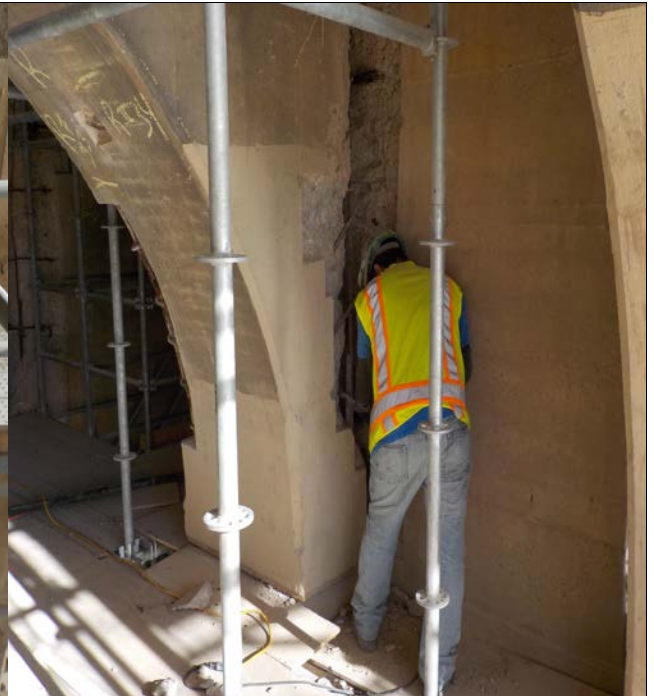
Chipping at Pier 3

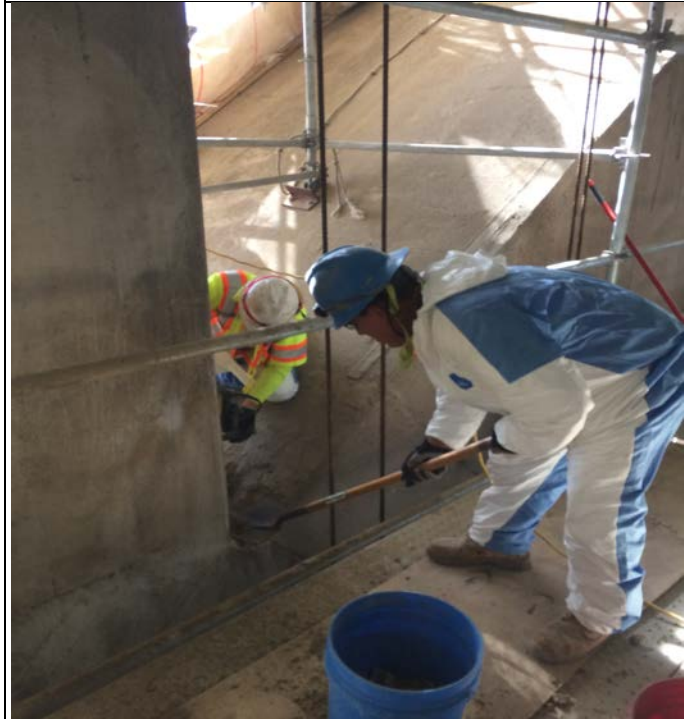
Removing and cleaning debris caught between spandrel and column at Span C

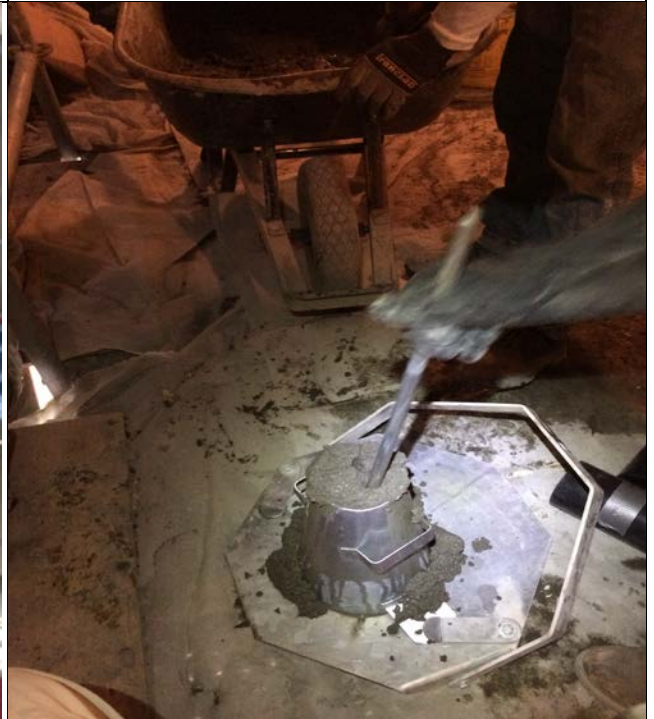
Conducting concrete slump test at Span C
